Fracture in MoS₂ Solid Lubricant Films

1 September 1995

M. R. HILTON Mechanics and Materials Technology Center Technology Operations

SPACE AND MISSILE SYSTEMS CENTER AIR FORCE MATERIEL COMMAND 2430 E. El Segundo Boulevard Los Angeles Air Force Base, CA 90245

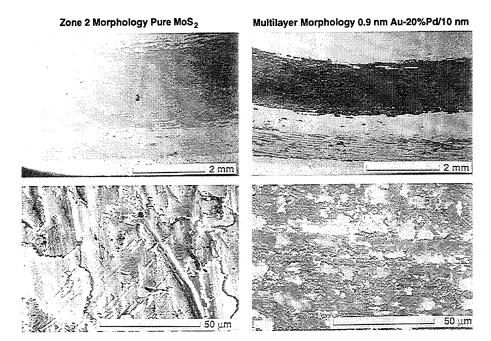
generation (wear) of fine MoS2 particles as postulated in the model of intercrystalline slip. However, in many cases, discrete film spallation has been observed. Fig. 1 shows electron micrographs of thrust bearing raceways lubricated with MoS₂ films having zone 2 and dense MoS₂ morphologies. The raceways were disassembled after 50 000 revolutions (50 krevs). In both cases, significant film spallation was observed. Large film particles had transferred onto the originally unlubricated balls and retainers. The bearings were reassembled and the films functioned with acceptable torque for 600-2000 krevs before failure (which was defined as a tenfold rise in torque above operational values). While such particle lubrication may be adequate for torque noise tolerant applications, as in these thrust bearing tests, this process was found to increase torque noise (jitter) to unacceptable levels in tests of angular contact bearings [15].

Fig. 1. Scanning electron micrographs of two 440C steel thrust bearing raceways (INA W1-1/2) disassembled after 50 krevs. The bearing raceways were lubricated with MoS_2 films: a zone 2 film (left) and a 0.9 nm Au-20%Pd/10 nm multilayer film (right). The balls and steel cages were not lubricated. The bearings had been running with adequately low, stable torque. However, significant film spallation occurred on both raceways. The bearings were reassembled and they operated with low torque for 2000 krevs and 600 krevs respectively. Original magnification: $18 \times \text{(top)}$, $1000 \times \text{(bottom)}$. Test conditions: 2500 rev min⁻¹; 0.5 GPa mean hertzian stress; 1 atm dry nitrogen. For further details, see Ref. [14].

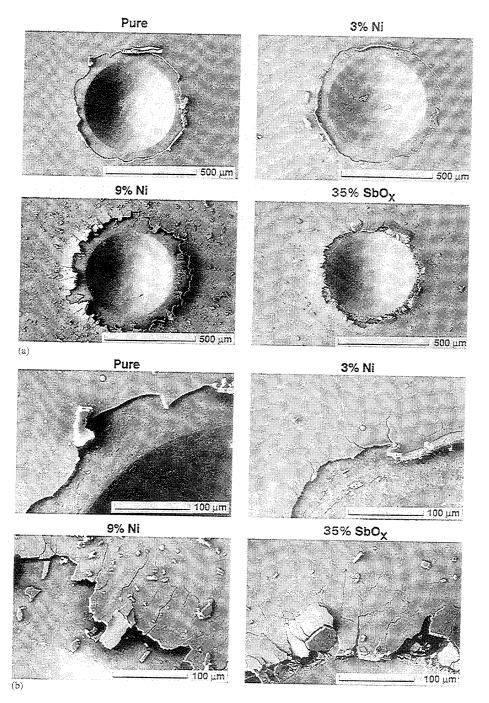
Fig. 2. (A) Scanning electron micrographs of the brale indentations of the co-sputtered films. (B) At higher magnification, radial fracture is noticeable in the films having higher concentrations of Ni or SbO_x -containing film has significant branched radial fracture with little delamination.

Fig. 2 shows micrographs of the 160 kgf indentations of the co-sputtered films. The pure MoS_2 film shows

simple delamination. The 3% Ni film has comparable complete delamination with some radial cracking extending beyond the delamination region. The 9% Ni film has more radial cracking, and the remnant film adjacent to the radial cracks appears delaminated (SEM at high tilt angle confirms this observation, but the exact extent of film-substrate fracture under the curled, remnant pieces is difficult to confirm). The 35%SbO_x-MoS₂ film has the least delamination, although Fig. 2 shows that significant branched, radial cracking is present. In Fig. 3, the extent of damage, i.e. fracture plus radial cracking, with and without the indentation radius is plotted as a function of load. The plotted extent of damage includes radial cracking, i.e. curled, delaminated film that has not fully detached. If pure delamination is plotted, the 9% Ni films are (erroneously) construed as showing less damage. Since the radial cracks in the SbO_x film are difficult to see in the lower magnification micrographs of Fig. 2, values based on the higher magnification micrographs are also plotted.

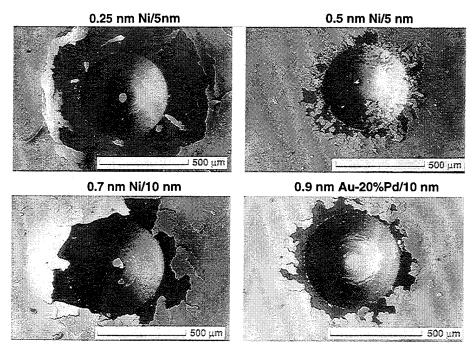
Micrographs of the indentations of some of the group II films are shown in Fig. 4 and delamination and fracture data are plotted in Fig. 5. The pure (micro not shown) and 0.25 nm Ni/5 nm films show extensive delamination without radial cracking. Indeed, the 0.25 nm Ni/5 nm film shows more delamination than the pure film. There is an abrupt transition in fracture mode appearance between the 0.25 nm Ni/5 nm and 0.5 nm Ni/5 nm films. The latter film shows less delamination, but exhibits a network of finely spaced radial cracks, with significant branching. The 0.75 nm Ni/5 nm and 1 nm Ni/5 nm films (micros not shown) have a similar appearance to the 0.5 nm Ni/5 nm film. The 0.7 nm Ni/10 nm film shows significantly more delamination and fracture than 5 nm periodicity films with 0.5-1 nm Ni. The 0.9 nm Au-20%Pd/10 nm film shows less delamination than the 0.7 nm Ni/10 nm film.

Fig. 4. Scanning electron micrographs of the brale indentations of some of the group II multilayer films. There is a dramatic suppression of delamination fracture in the 0.5 nm Ni/5 nm film relative to the 0.25 nm Ni/5 nm film. A fine network of branched, radial cracks is also present in the 0.5 nm Ni/5 nm film. More delamination is present in the 10 nm periodicity films.

a dramatic increase in fracture resistance when the metal thickness is increased from 0.25 to 0.5 nm. The fine networks of cracks suggest that the multilayers induce significant radial crack branching. Clearly, the nanostructure is changing in a manner that affects crack propagation. Although the multilayer periodicities of these films were accurately determined by X-ray diffraction, the actual film nanostructures are not known. These metal thicknesses are averages based on deposition rates. For example, it is very doubtful that the thin metal layers are continuous and we do not yet know what quantity of deposited metal is required for a continuous layer to form. At 10 nm periodicity, the limited data suggest that Au-20%Pd is more effective than Ni in inhibiting fracture. This is fortunate as friction data favor Au-20%Pd over Ni [13].
